# **Grading / Geotech**

Date: March 30, 2004  
Subject: 606 E. Ave San Juan  
Geotechnical Review

SUBJECT: Preliminary Geotechnical Investigation of Distressed Residential Property, 606 E. Avenida San Juan, San Clemente, California

Subject: **Preliminary Geotechnical Investigation for Foundation Design**  
Proposed New Residential Construction  
606 Avenida San Juan  
San Clemente, California

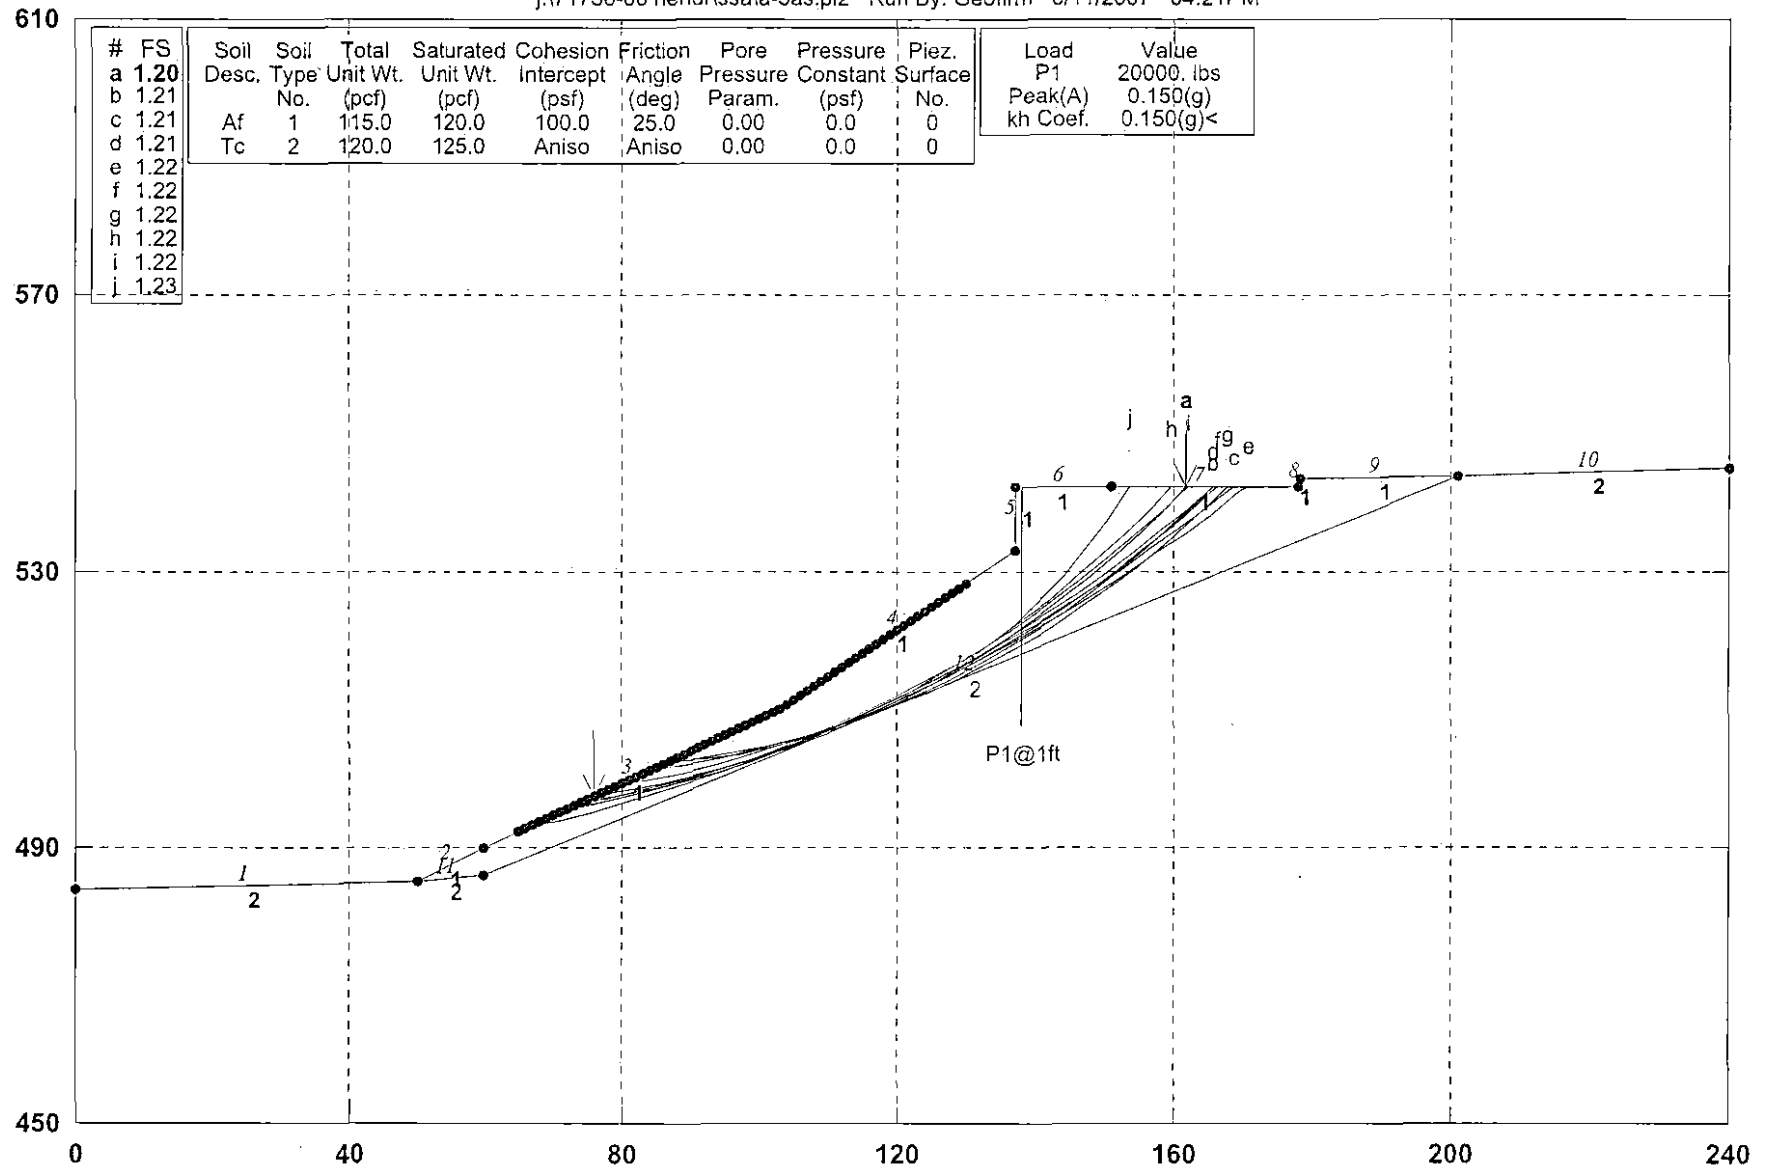
# 71736-00, Hendrickson, section A-A', , Circular mode, seismic, with piers

GSTABL7 v.2 FSmin=1.20

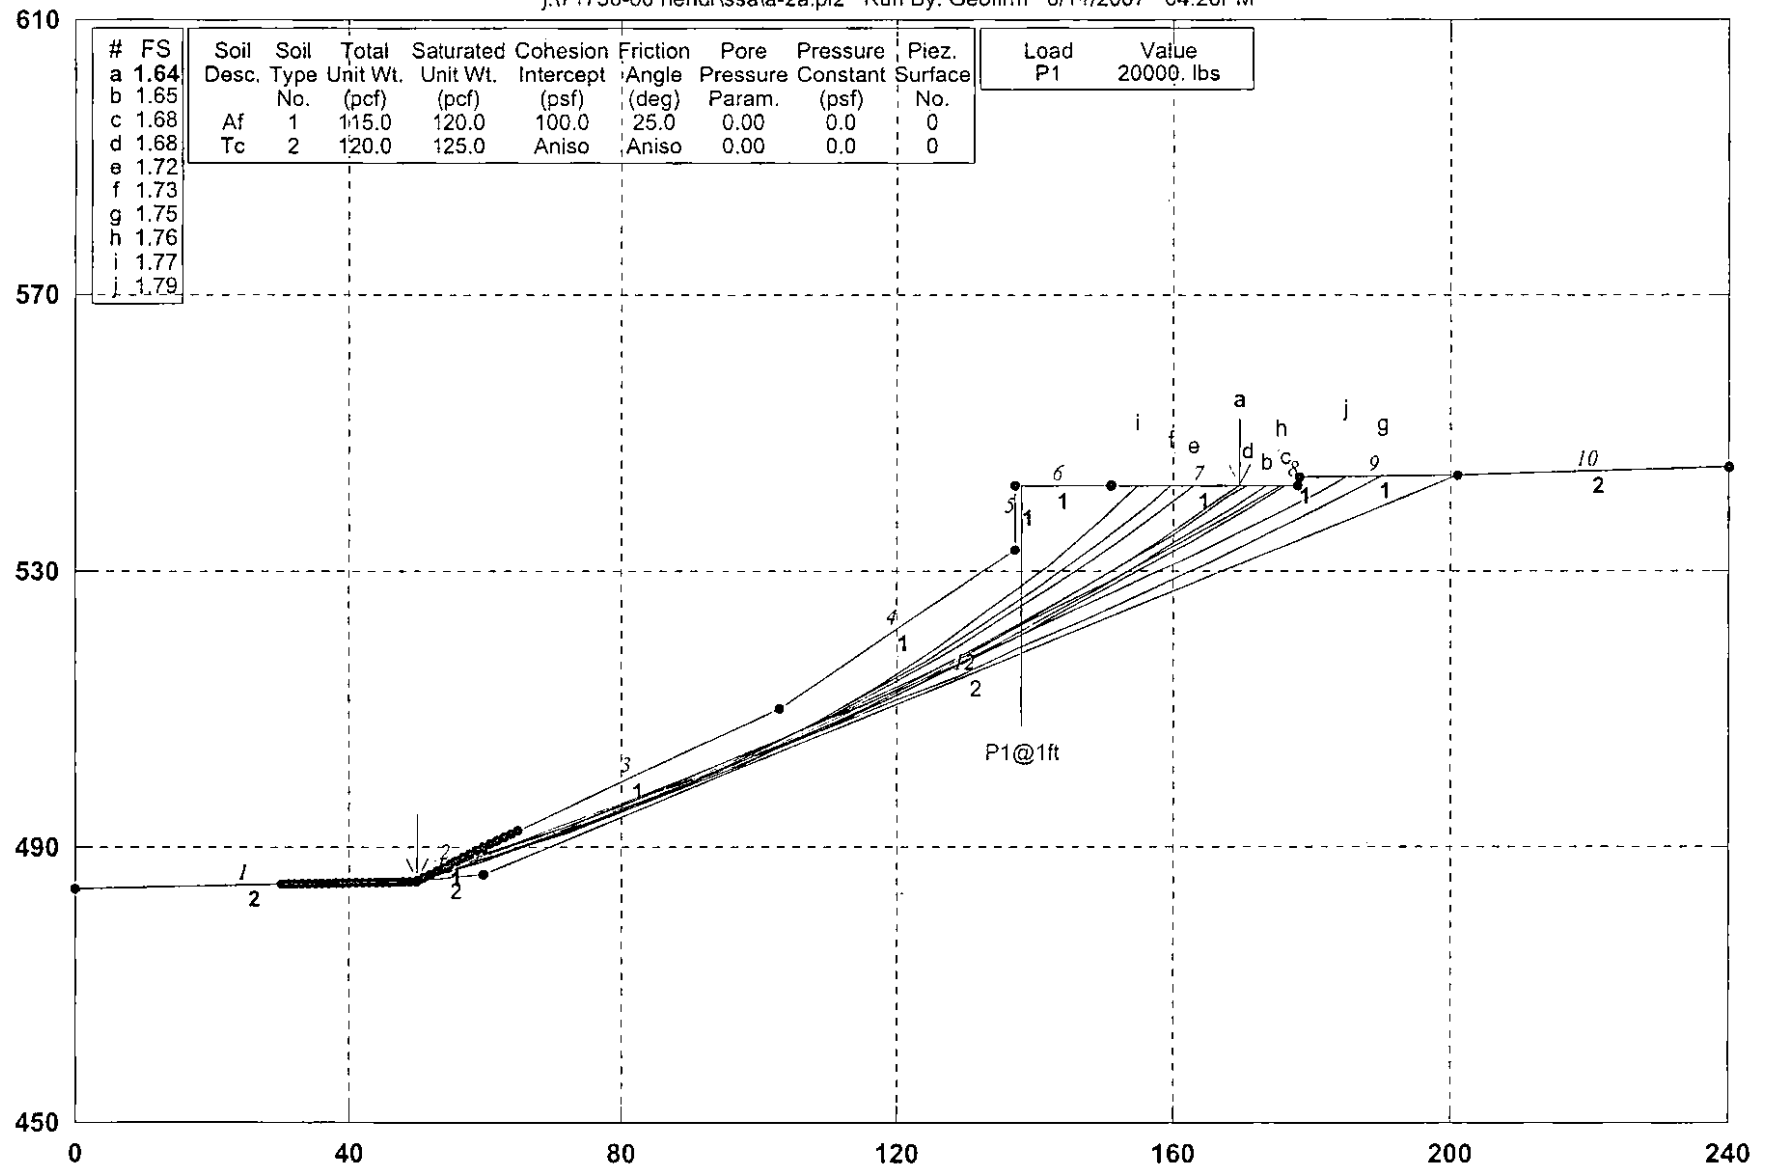
# 71736-00, Hendrickson, section A-A', , Circular mode, static, with piers

GSTABL7 v.2 FSmin=1.64
