Date: March 11, 2004
Subject: 606 E. Ave San Juan
Geotechnical Review

→ SUBJECT: Preliminary Geotechnical Investigation of Distressed Residential Property, 606 E. Avenida San Juan, San Clemente, California

JN 01G1474

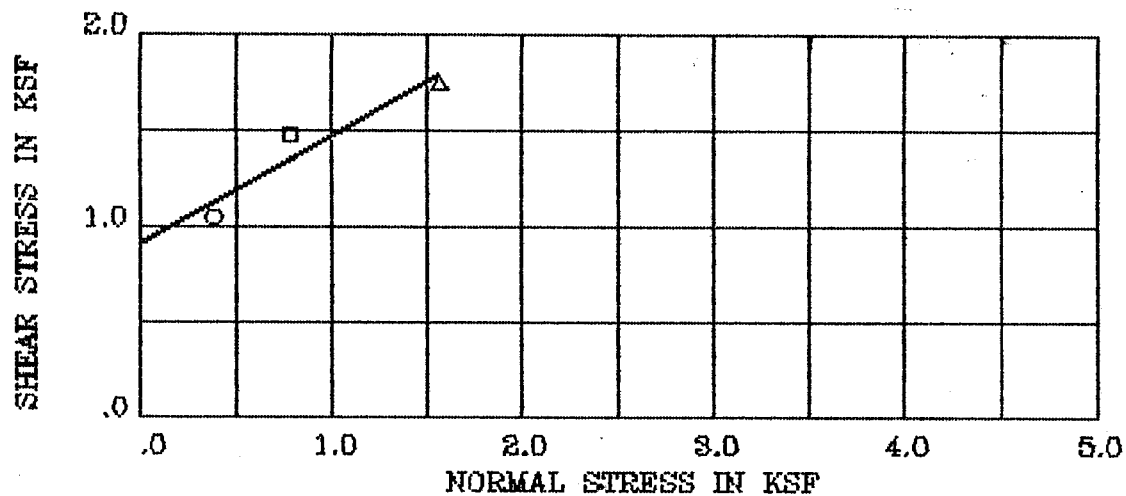
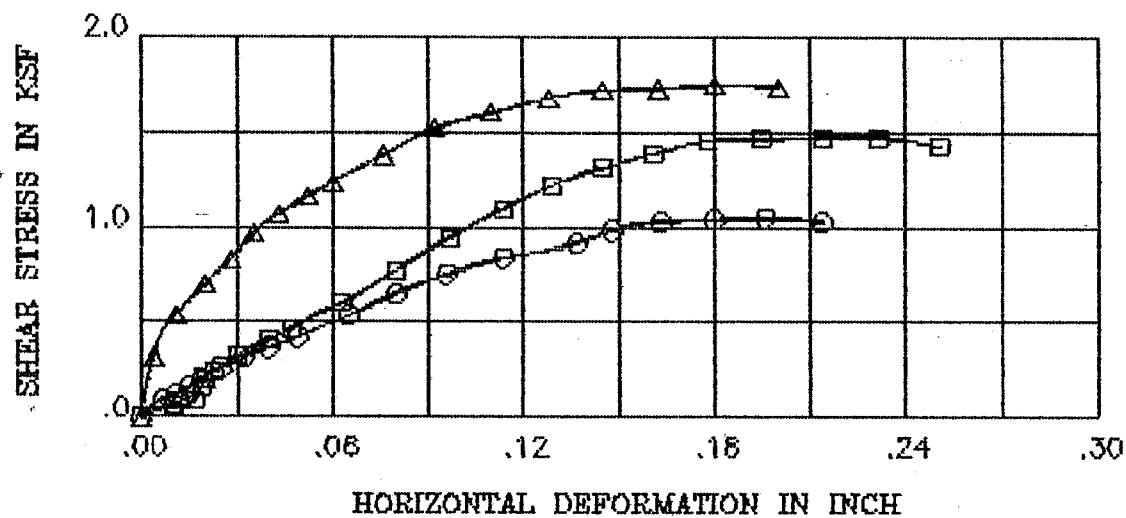
Project No.01G1474	SCHOTANUS
PETER & ASSOCIATES	DIRECT SHEAR TEST

BORING/SAMPLE : 1 DEPTH (ft) : 20
 DESCRIPTION : SALTSTONE BEDROCK
 STRENGTH INTERCEPT (C) : .913 KSF
 FRICTION ANGLE (PHI) : 29.1 DEG (PEAK STRENGTH)

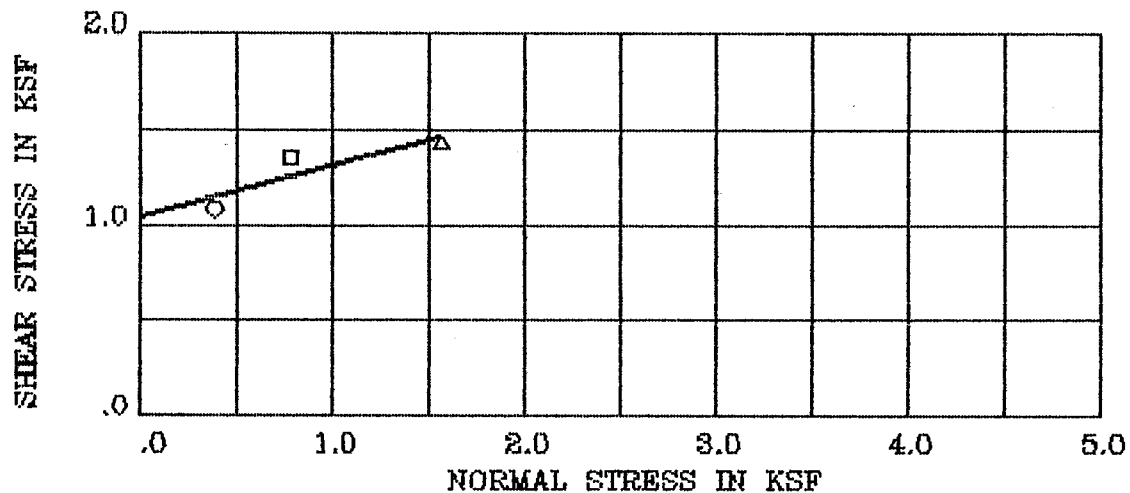
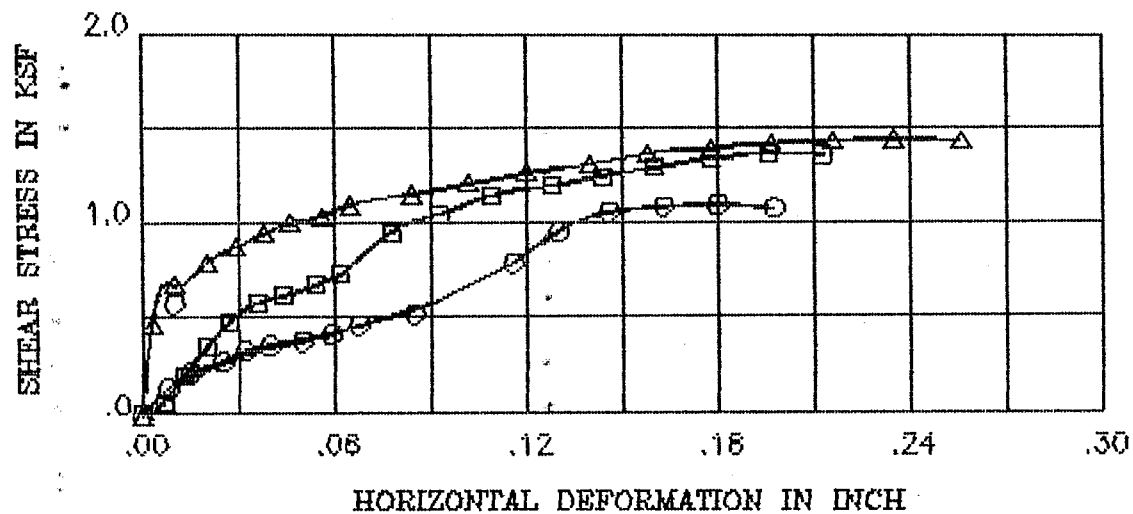
Project No.01G1474	SCHOTANUS
PETER & ASSOCIATES	DIRECT SHEAR TEST

BORING/SAMPLE : 2 DEPTH (ft) : 5
 DESCRIPTION : ARTIFICIAL FILL--SILT--1ST BREAK BEFORE RESHEARS
 STRENGTH INTERCEPT (C) : 1.048 KSF
 FRICTION ANGLE (PHI) : 14.9 DEG (PEAK STRENGTH)

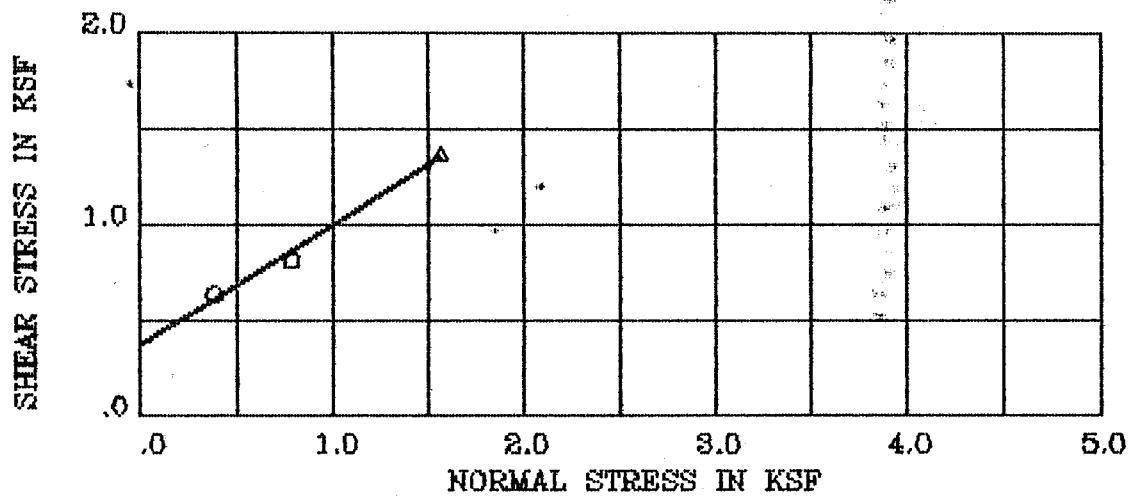
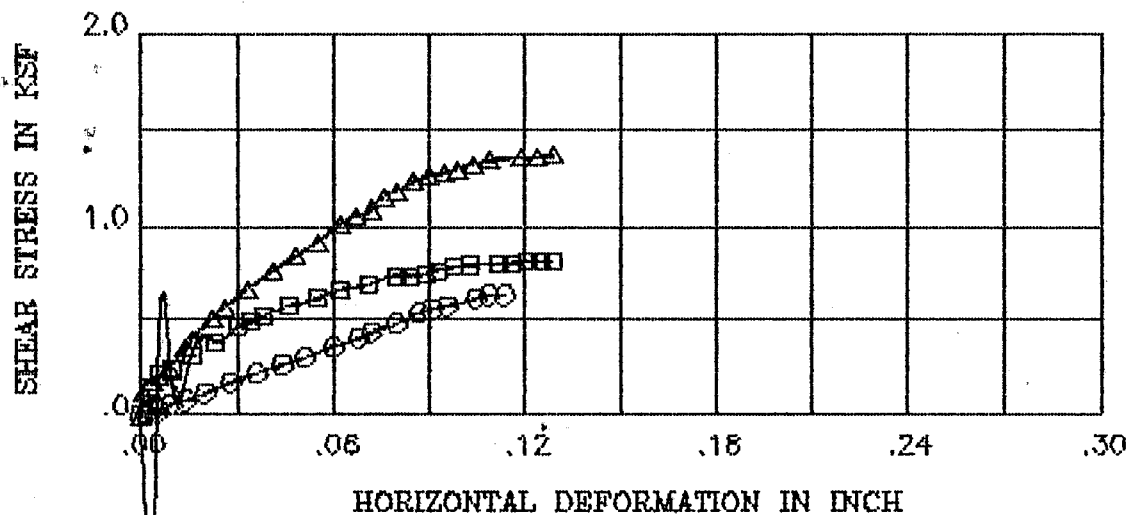
BORING/SAMPLE : 2 DEPTH (ft) : 10
 DESCRIPTION :
 STRENGTH INTERCEPT (C) : .361 KSF (PEAK STRENGTH)
 FRICTION ANGLE (PHI) : 32.2 DEG

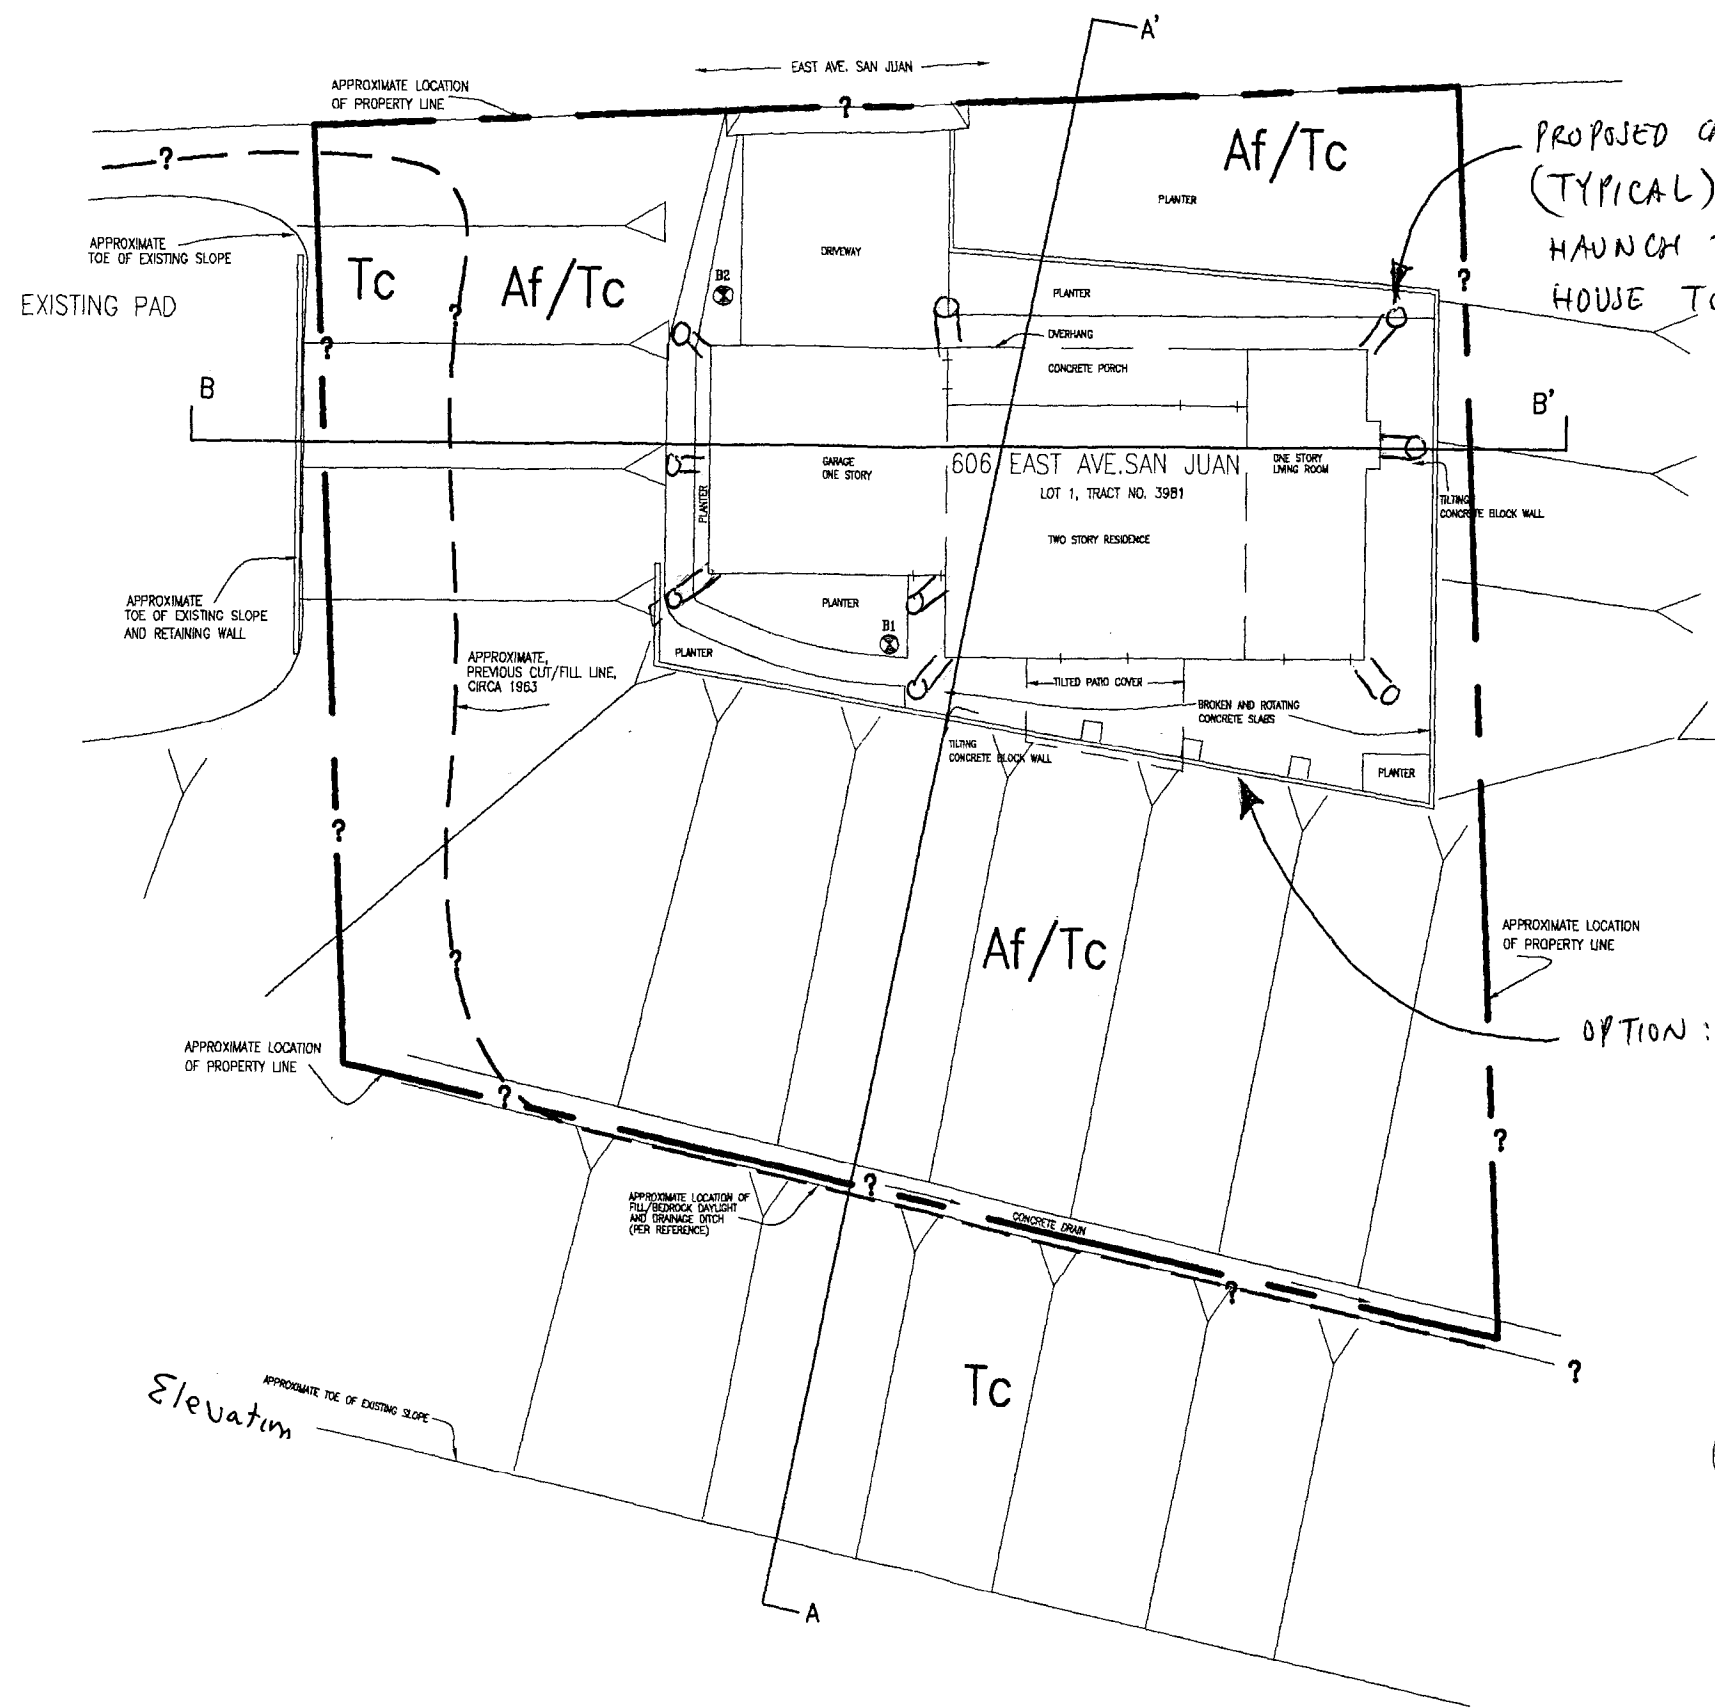
FIGURE 5

PROPOSED CAISSON + HAUNCH + (GRADE BEAM)
(TYPICAL) - ADDITIONAL CAISSON & GRADE BEAM +
HAUNCH TO SUPPORT INTERIOR WALLS & ENTIRE
HOUSE TO BE DETERMINED BY STRUCTURAL ENGINEER.

OPTION: EXISTING REAR FENCE WALL CAN BE
REMOVED AND REPLACED WITH NEW WALL
TO BE SUPPORTED BY CAISSONS.
CAISSONS SUPPORTING THE HOUSE WALLS
CAN BE USED TO ADDITIONALLY SUPPORT
FENCE WALL + PATIO COVER COLUMNS
+ OTHER IMPROVEMENTS, AS NEEDED
